**[9] SELF DIAGNOSTICS****1. General**

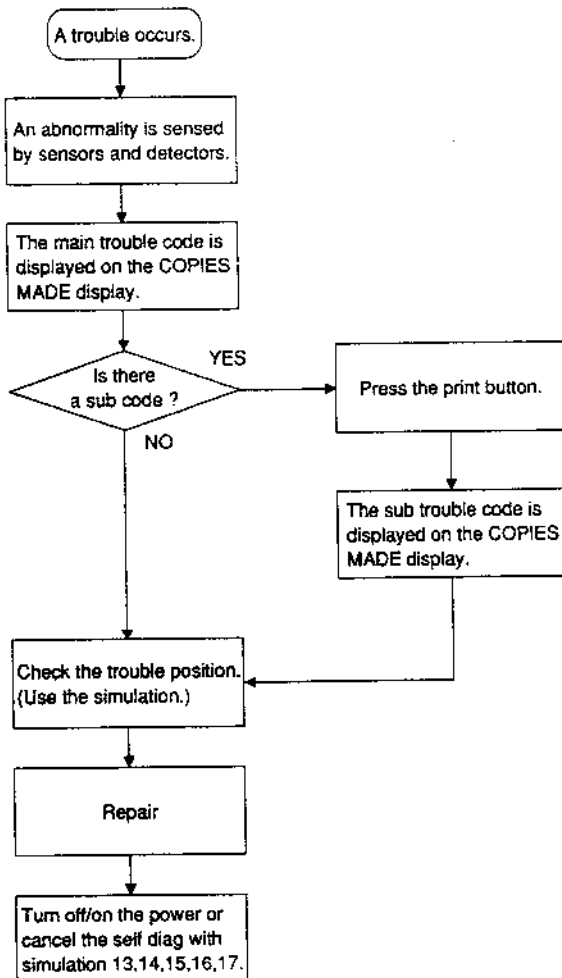
**2. Self diag operations and flowchart**

This machine has self diagnostics to notify the customer and the serviceman when a trouble occurs during machine operation. The purposes of self diagnostics are as follows:

- 1) To assure safety when a trouble is sensed, the machine is stopped simultaneously.
- 2) To minimize machine damage, when a trouble is sensed, the machine is stopped simultaneously.
- 3) To know the exact area of the machine where the trouble occurred by using trouble codes, thereby shortening the recovery time of the machine. (For improved repair efficiency, the repair parts should be arranged in advance.)
